Operation UPSHOT-KNOTHOLE

March - June 1953

Project 3.6

TESTS ON THE LOADING AND RESPONSE OF
RAILROAD EQUIPMENT

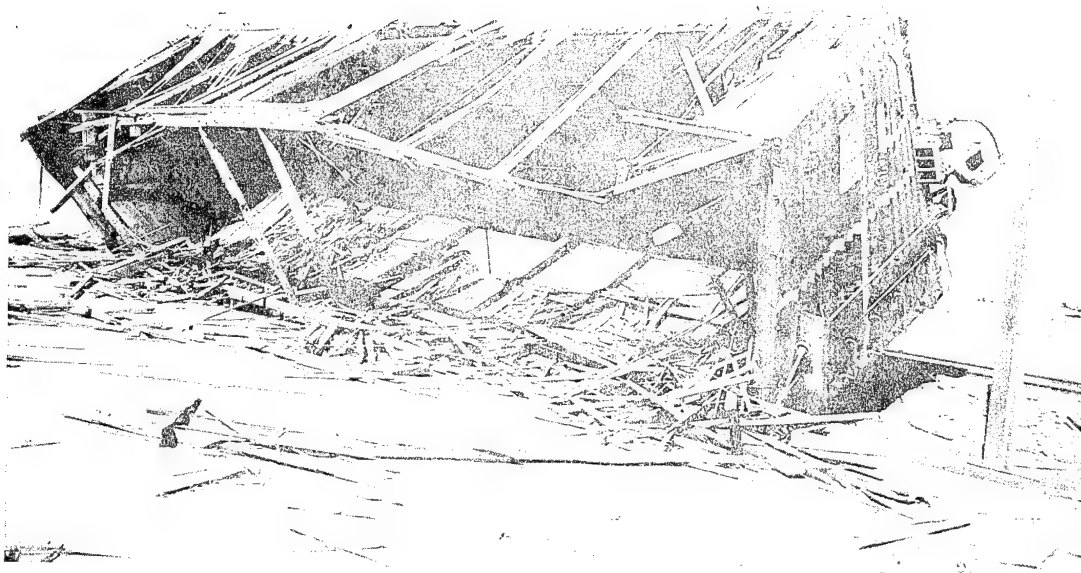
Fig. 4.10 Postshot, Damage to Wooden Boxcar, 3.6f

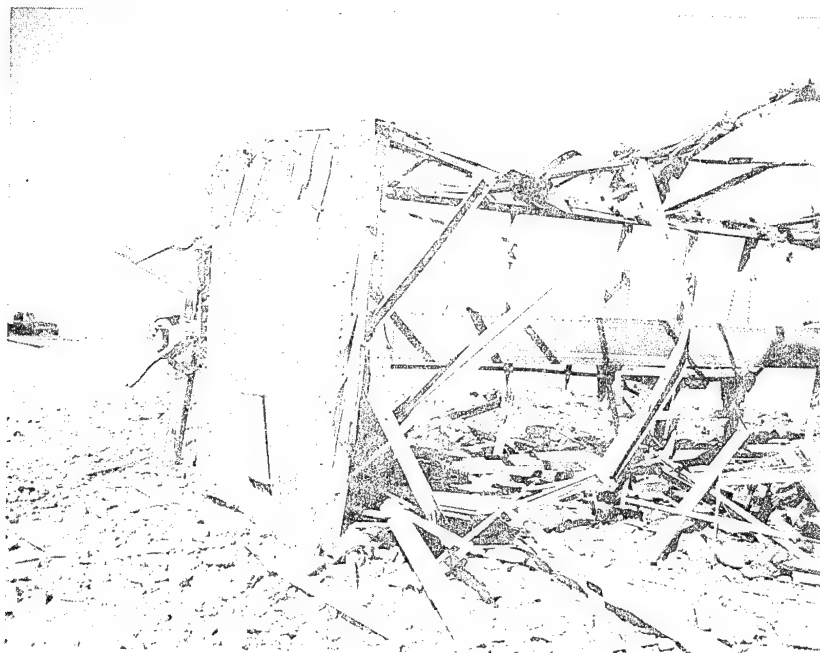
Fig. 4.14 Postshot, Damage to Loaded Wooden Boxcar, 3.6j (Note bowed ends and severe damage to box structure and frame)

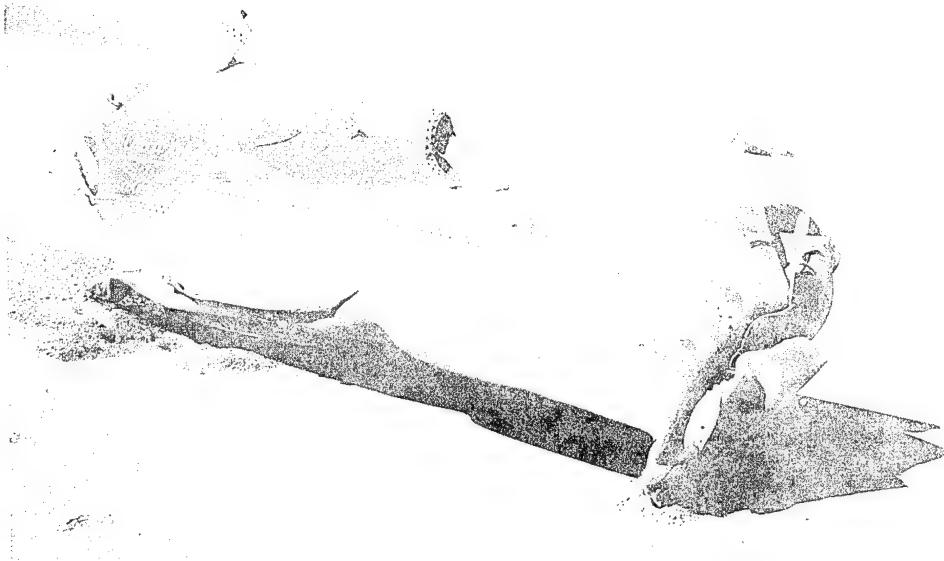
Fig. 4.20 Postshot, Damage to Shell of Riveted Tank Car, 3.6n
